Study of aeroelastic interference effect among four cylinders arranged in rectangular configuration

S. Hračov^a, M. Macháček^a, P. Michálek^a

^a Institute of Theoretical and Applied Mechanics, Czech Academy of Sciences, Prosecká 76, 19000 Prague., Czech Republic

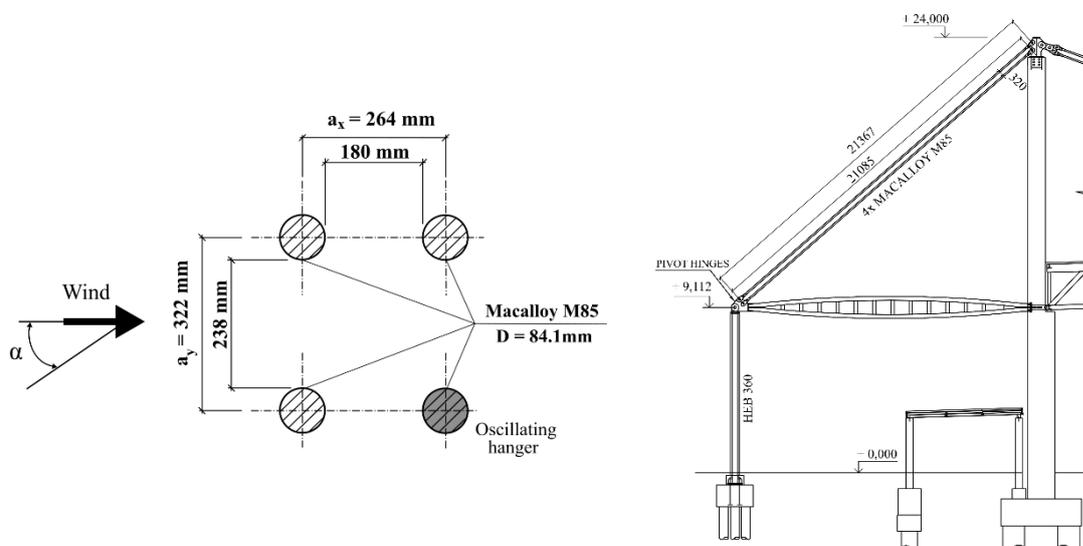
Fig. 1. Layout of hangers (left) and scheme of the part of roof supporting structure with hangers (right)

This abstract deals with an analysis of the aerodynamic vibration of a group of four existing hangers supporting the hangar roof and creating in cross-section the rectangular array, see Fig. 1. It is especially concentrated upon the determination of the cause of the violent vibration of one of the hangers. In particular, the excessive vibration of the bottom downwind hanger in the across wind direction was observed, while the rest of hangers remained nearly stationary. The dominant vibration mode of the hanger was characterized by a one node in the middle of the length and by frequency $f = 5.85$ Hz. It corresponds to the second resonant frequency identified from the spectrum of the response related to hammer impact test. All four hangers in the form of tension rods have the same diameter, $D = 84.1$ mm, mass per unit length $\mu = 43.6$ kgm⁻¹ and almost identical length 21 m and modal properties. The normalized distance between hangers in horizontal and vertical directions is equal to $3.15 D$, and $3.8 D$, respectively. The relatively high Scruton number of the hanger, $Sc = 59.2$, was determined for the expected very low logarithmic decrement of structural damping, $\mathcal{D} = 0.006$.

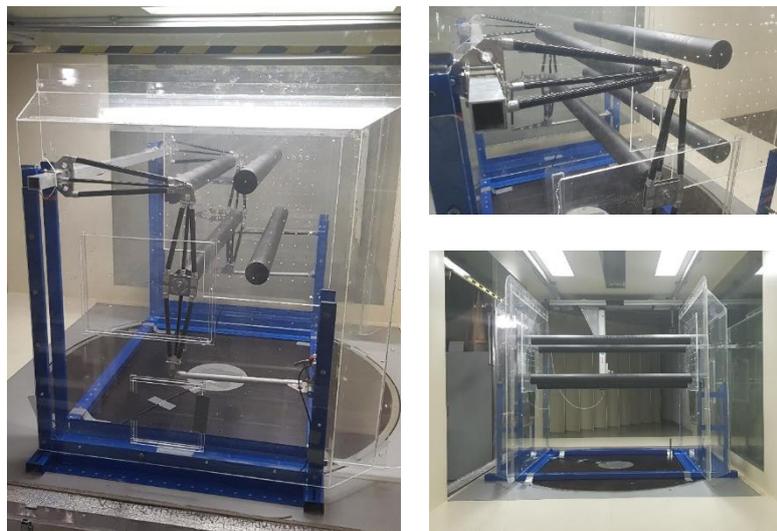
Fig. 2. Experimental set-up with mounted cylinders represented a real configuration of hangers

Aero-elastic stability and dynamic behavior of the bottom downwind hanger as a vibrating member of the tetrad of the rods were investigated experimentally in the wind tunnel of ITAM AS CR in Telč in the Czech Republic. The experimental model of each hanger was represented by 1.3-meter long plastic cylinder with the real cross section. Thus identical flow conditions around the cylinder as in reality i.e. same Reynolds number was reached. The cylinders were fixed horizontally to a specially designed experimental stand, see Fig. 2.

The bottom downwind hanger was placed into the special mechanism of this set-up allowing only the vertical (cross wind direction) movement. The stand enabled to analyze the influence of two values of Scruton number ($Sc = 44$ and $Sc = 79$) on aeroelastic instability of the cylinder, while its natural frequency ($f = 2.6 \text{ Hz}$) and the damping ratio ($\zeta = 1.5 \%$) remained fixed. The lower natural frequency than in the real case was chosen due to mechanical restrictions of the stand. The low value selected in this way allows also to reduce the influence of vortex shedding emerging at wind velocity below 3 ms^{-1} on the instabilities occurring at higher wind speeds. The other three cylinders from tetrad were assumed as stationary, i.e. non-vibrating and were fixed between two plastic end-plates of the stand. Two positions of these fixed hangers were investigated in order to simulate two basic wind direction, i.e. $\alpha = 0^\circ$ and $\alpha = 10^\circ$, respectively, see Fig. 1. The latter case represents the critical wind incidence angle for the interference galloping [2]. In addition, behavior of an isolated hanger and a pair of hangers in the horizontal row were tested to compare the susceptibility to the aero-elastic instability with the full rectangular array configuration.

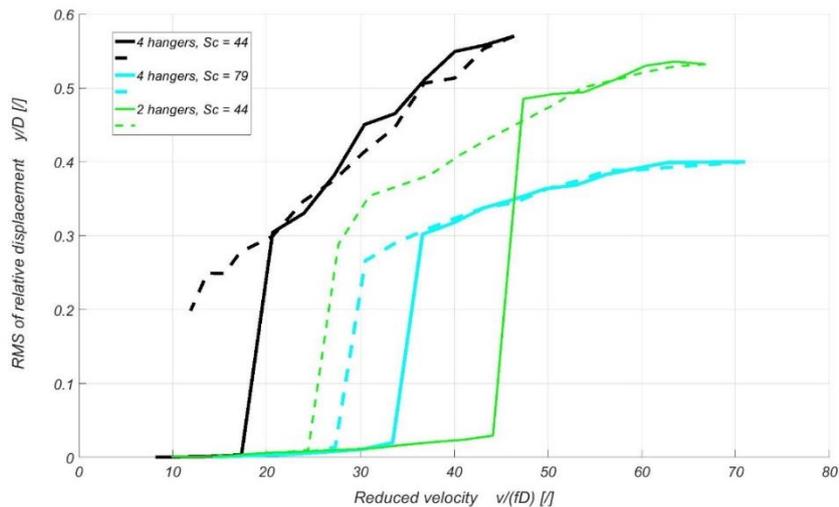
Fig. 3. Root Mean Square (RMS) value of relative displacement of the oscillating cylinder as a function of reduced velocity (solid line – increasing velocity branch, dashed line – decreasing velocity branch)

The experiments of all analyzed groups of hangers under the wind flow incidence angle $\alpha = 10^\circ$ revealed sudden and significant increase of the cross-wind vibration response of the bottom downwind hanger at certain critical wind speed. By reaching the critical velocity, the harmonic response with high amplitudes was observed. Increase of the velocity above the critical one leads to the further increase of the response amplitude. It is documented in Fig. 3 in terms of RMS value of measured relative displacement for both the pair and the tetrad of hangers possessing the same and different Scruton numbers, Sc . For identical Sc , the outset of vibrations with high amplitudes for the rectangular array was detected at approximately two times lower reduced wind speed than for the pair of hangers. This implies on a significant influence of the upper row of hangers on interference galloping of downwind hanger in the bottom row. When comparing two groups of 4 hangers for different Sc , the initiation of instability for the higher Sc is becoming as expected at higher reduced wind velocity than for smaller Sc . The ratio between reduced critical wind speeds for these cases with different Sc equal to 1.34. It is a slightly higher than the square root of ratio of corresponding Sc equal to 1.84, which is relation between both critical velocities when applying formula (1). It should be also noted, that the level of vibration for higher Sc was lower than for smaller Sc as expected.

Strong hysteresis behavior was observed during whole testing process. The bottom downwind cylinder in the rectangular array as well as the downwind cylinder in a pair were oscillating with high amplitudes not only above the critical wind velocity, but also when the wind velocity was decreased below the critical one, see the dashed lines in Fig. 3. However, with further decrease in wind velocity at some moment a sudden significant reduction in the response occurred. This holds for all of the analyzed configurations.
